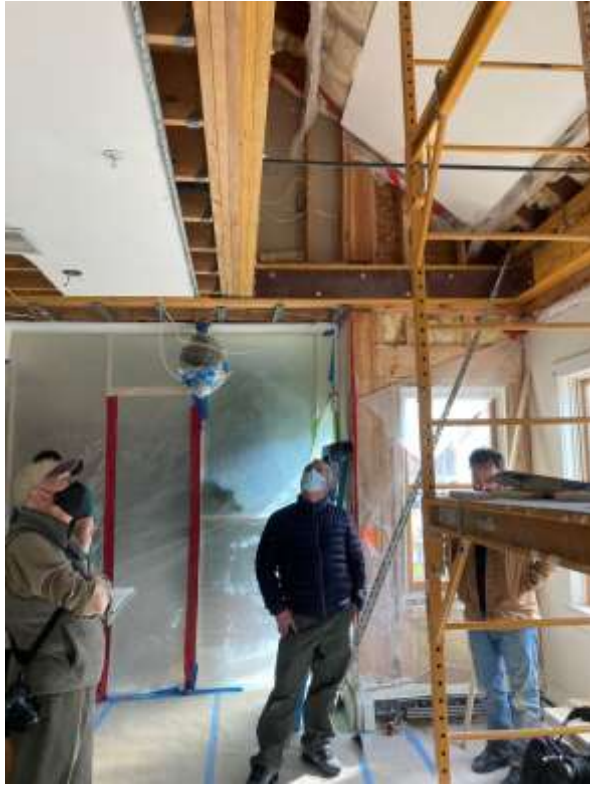
Photo #1: The steel plates, tie rods, and LVL reinforcing beams have all been installed at this time.

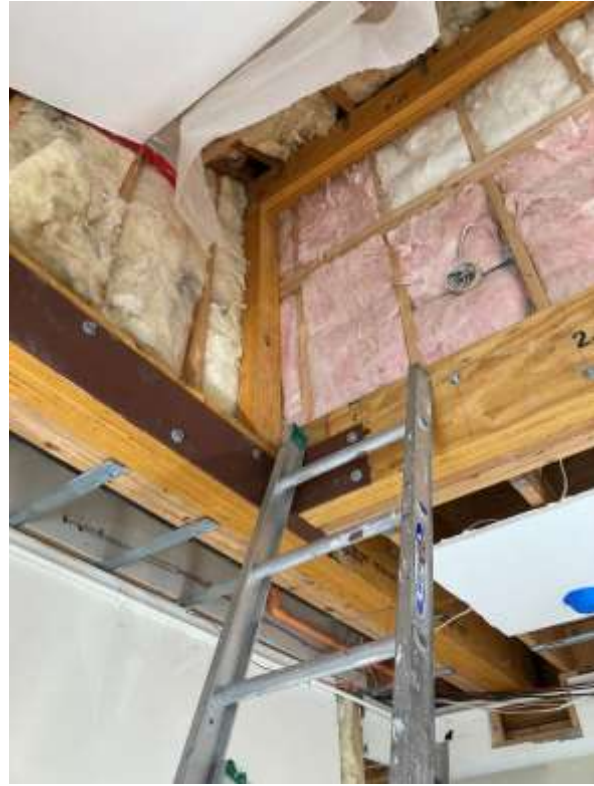
Photo #2: Close up view of the steel beam support reinforcing tie plate. The tie rod can also be seen piercing through the mezzanine framing, tying the rotated window header, reinforced with new LVLs, back to the floor structure.

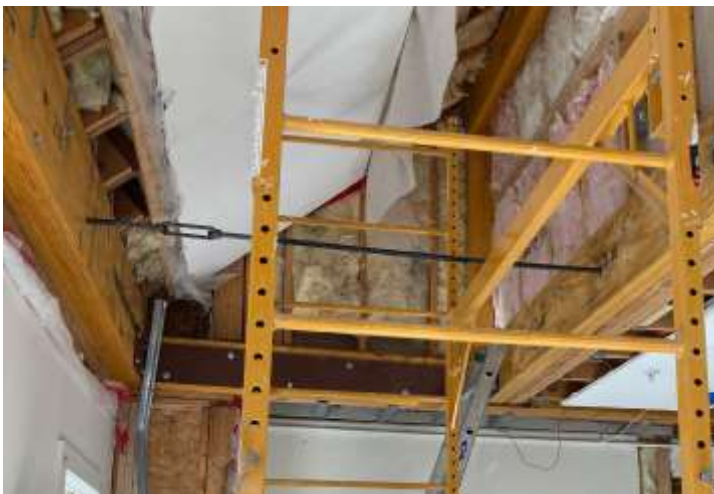
Photo #3: Steel rods with turnbuckles tie the rotated window header, reinforced with new LVLs, back to the mezzanine floor framing.

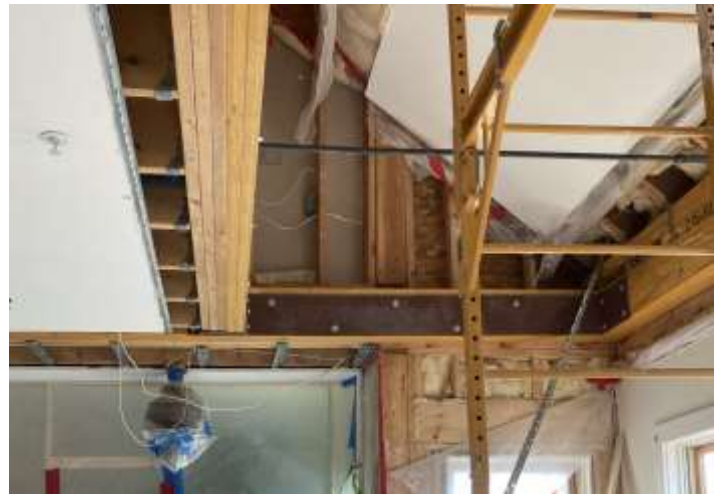
Photo #4: The LVL posts supporting the new auxiliary LVL roof beam have been installed.
